Subject: Leaks Around the IVT Oil Mist Header Switching Valve

This TECH-Bulletin is provided to address reported oil leaks experienced in the field on Model IVT Oil Mist Generators that originate around the outlet switching valve. Leaks are reported from several points around the valve. The identified locations are;

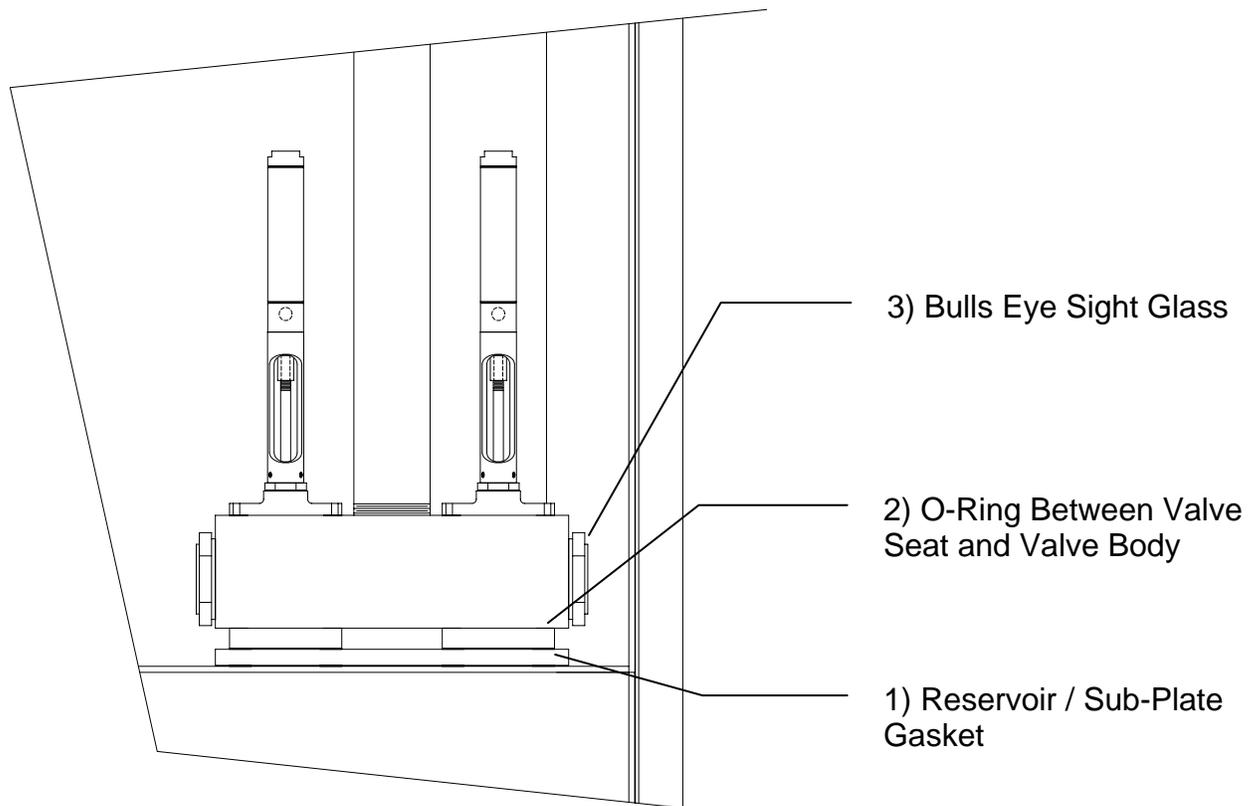
Fig 1

1. Around the gaskets between the reservoir / valve seat and sub-plate
2. Around the o-ring seal between the valve seat ring and the switching valve body
3. Around the bulls eye sight glass

IMPORTANT NOTE: Improper mist header installation and is a possible cause for oil leaks at this location. Proper oil mist header alignment and connection to the 2" mist outlet connection flange is necessary. Using force (pushing the piping) to correct misalignment between the mist outlet flange on the IVT Oil Mist Generator and the matching flange at the oil mist header may result in a leaking gasket surface. Pulling the IVT mist outlet connection pipe to compensate for misalignment may create leak at the gaskets between the switching valve and the reservoir. Before undertaking any repair and replacement of gaskets under the switching valve ensure that the mist outlet connection flange and the matching flange at the oil mist header properly align and make up without using force. Failure to do so may result in an ineffective repair.

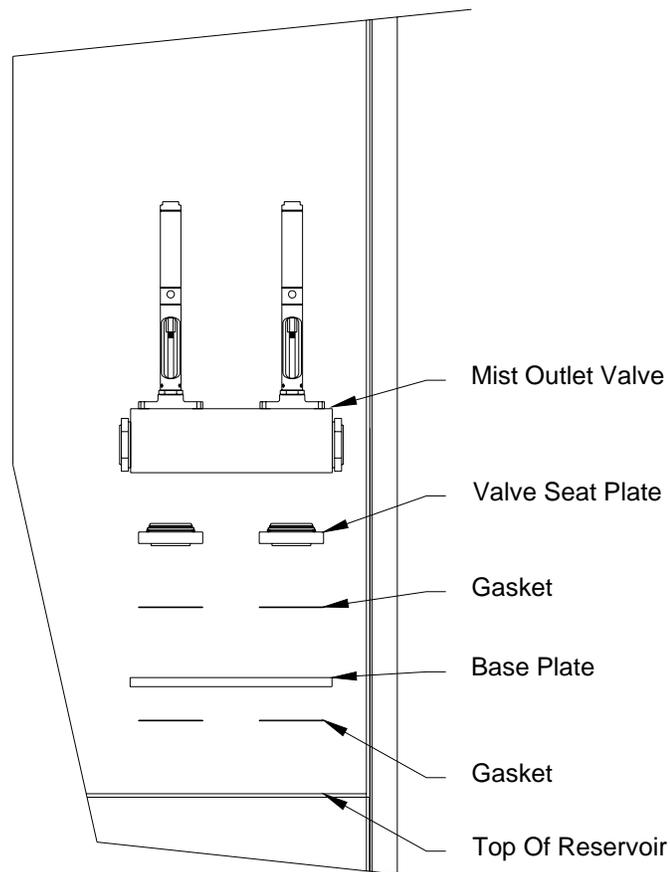
Fig 2

1) Gaskets between the reservoir / valve seat and sub-plate

One leak is identified at the gasket between the reservoir and base plate or the valve seat plate and the mist out valve body. These seals are made using gaskets. The valve body and the base plate are machined components and have flat gasket surfaces. However the mating gasket surface on the reservoir is not a machined surface. The possibility of having a leak at this location is created if the surfaces between the base plate and the reservoir are not parallel when assembled.

To ensure that a leak free seal is made, during assembly we are now applying a RTV gasket sealant to the gaskets between the valve seat plate and the base plate and the gaskets between the base plate and the top of the IVT reservoir. A prescribed sequence has also been implemented for tightening the bolts.

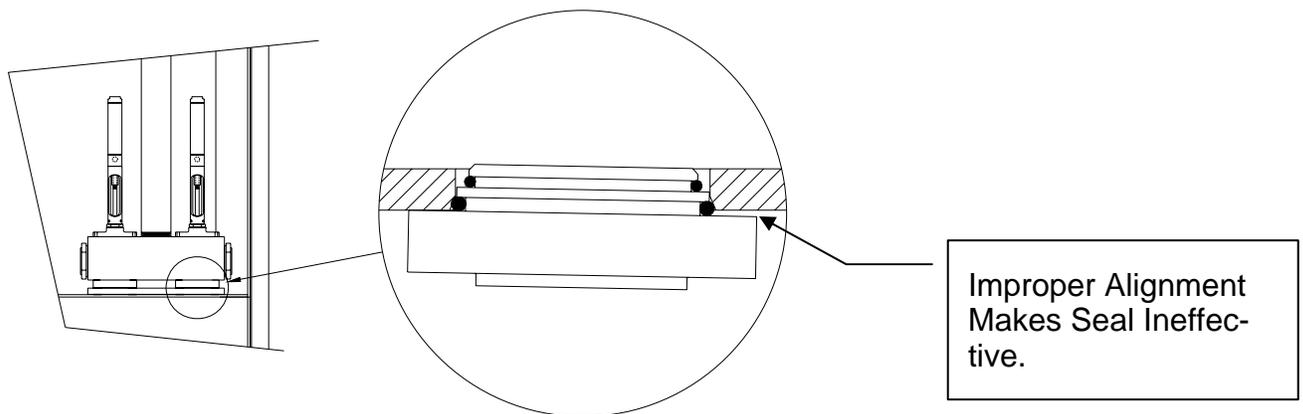
2) O-Ring Between Valve Seat and Valve Body

The interface between the valve seat and the valve body is made using a static o-ring seal. This seal detail is identical to the o-ring seal on top of the valve body between it and the valve stem seal cap. An un-effective seal results if the valve body is not properly assembled to the valve seat. Proper assembly is essential.

The correct valve body and valve seat assembly requires proper alignment and even tightening of the eight mounting bolts. If the valve body is not evenly tightened to the valve seats, the o-ring and o-ring seat can be misaligned and a leak results. See the diagram below.

When leaks described in this TECH Bulletin are being addressed as a field service repair, the mist outlet pipe must be loosened from the oil mist header. The pipe seal flange and cabinet flange must be unbolted so that the mist outlet pipe can move freely as the assembly is realigned and tightened. A repair made without allowing the mist outlet pipe to have free movement may not be effective (reference Fig 5 above).

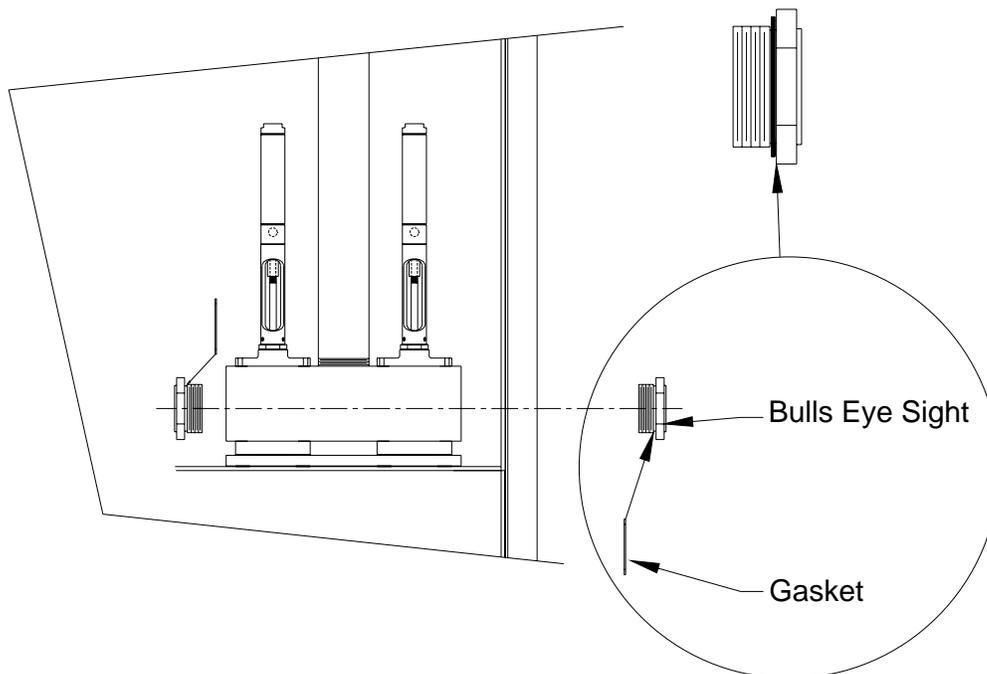
Fig 7

3) Bulls Eye Sight Glass

The gasket provided by the OEM supplier of the bulls eye sight glass is very narrow. Additionally there is a thread relief machined under the hex of the sight glass that has a smaller diameter than the ID of the gasket. This configuration allows the gasket to orbit around the center line of the sight glass when it is assembled. When the OEM was contacted, they offered no resolution, but responded that if the unit is properly installed it should not leak. Their response is not considered a complete solution to the problem. We are recommending that where leaking sight glasses are found, the original gaskets be removed and replaced with P/N 77780995 Gasket. The new gaskets are Buna-N impregnated cloth.

To install the new gaskets, unthread and remove the sight glass. Remove and discard the old paper gasket. Install the new gasket in the thread relief at the base of the sight glass' thread. Note that the gasket ID is smaller than the sight glass' major thread diameter. As the gasket is installed, it has to be stretched as it is pulled over the thread. Re-install and tighten the bulls eye sight glass.
