IAS Resolves Bacterial and Biological Contamination in Steam Turbine Lube Oil Reservoir and Related Systems

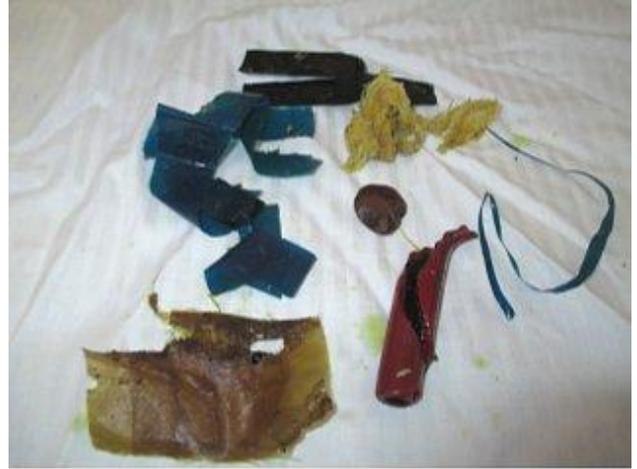
- RPVOT result is below 25% of new lube value
- RULER result shows low antioxidants; phenols are depleted and amines are below 50%
- Insoluble contamination is elevated
- Rust Prevention test failed
- ISO Particle Cleanliness is above the maximum recommended cleanliness of 18/16/13
- Water content is elevated; showing 1.1% water
- Elemental analysis reveals Calcium, which is not typical in turbine oils of this type
- Bacteria test revealed moderate to significant bacteria growth

Foreign Contaminants
Found in Reservoir

The bacteria and water is the cause of short service life on the system filters and bacteria has most likely spread throughout the entire lubrication system. The biological growth must be removed from the lubrication system prior to the installation of new turbine oil.

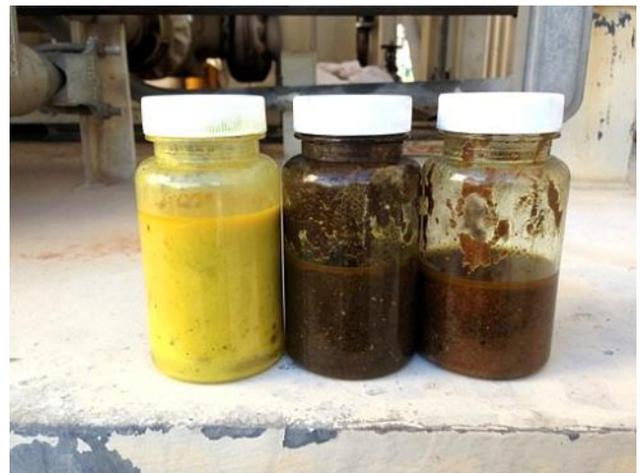
Bacteria, Water and Sludge Found
in Reservoir

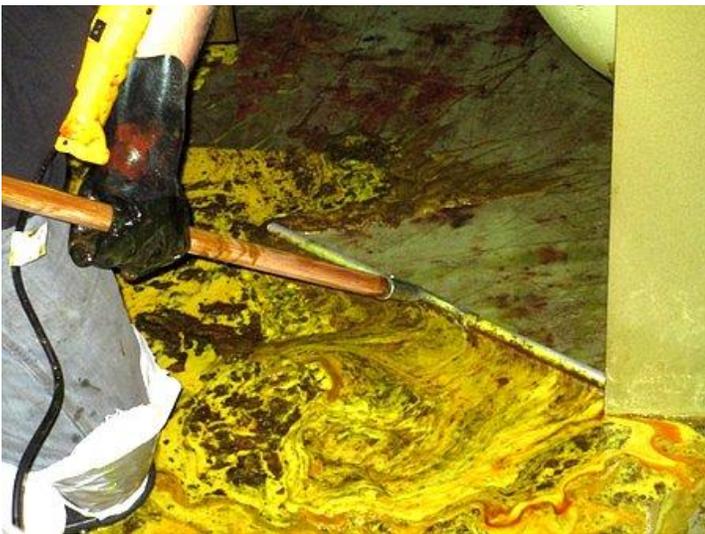
Reservoir sludge removal before cleaning

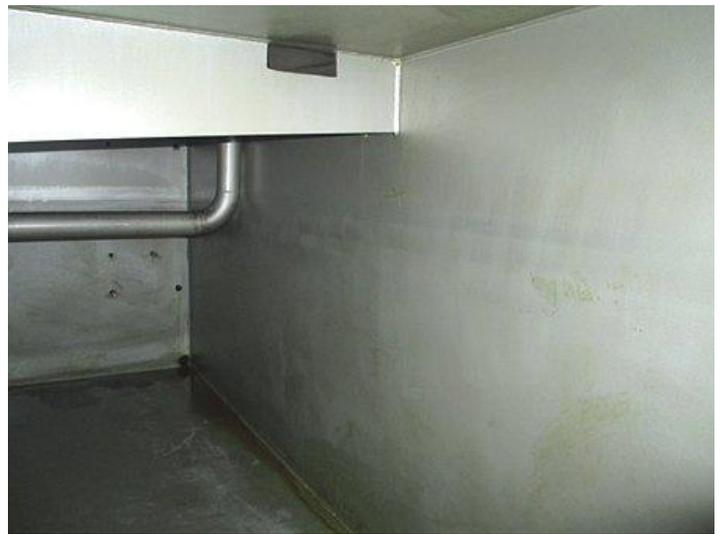
Reservoir Floor After Cleaning

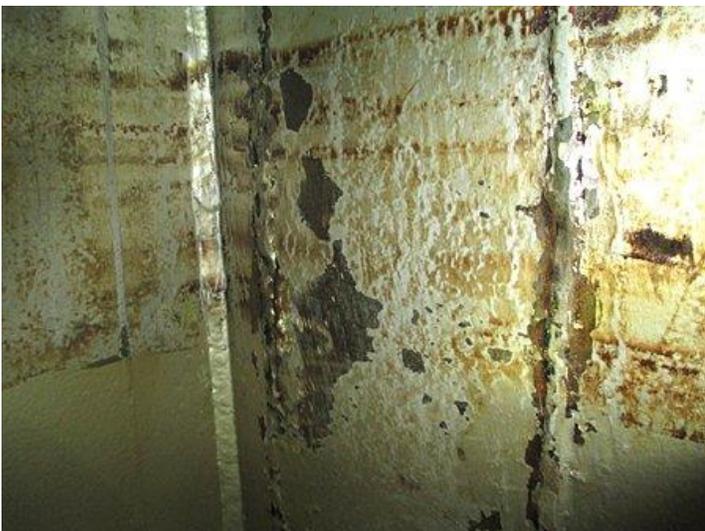
Reservoir walls before cleaning

IAS recommends performing a High Velocity Chemical Cleaning during the next planned outage to remove the rust in the lube oil system and reservoir. This process will remove rust, scale, corrosion, varnish and other organic and/or inorganic contamination. This service is always followed by a High Velocity Oil Flush.

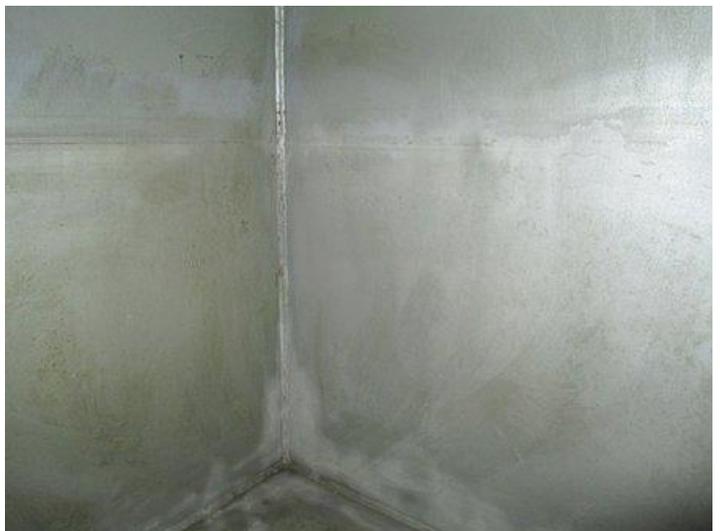
Reservoir walls after cleaning
